# Actuncan

# **Actuncan Archaeological Project: Report of the 2010 Field Season**

Report submitted to the Belize Institute of Archaeology

March 2011

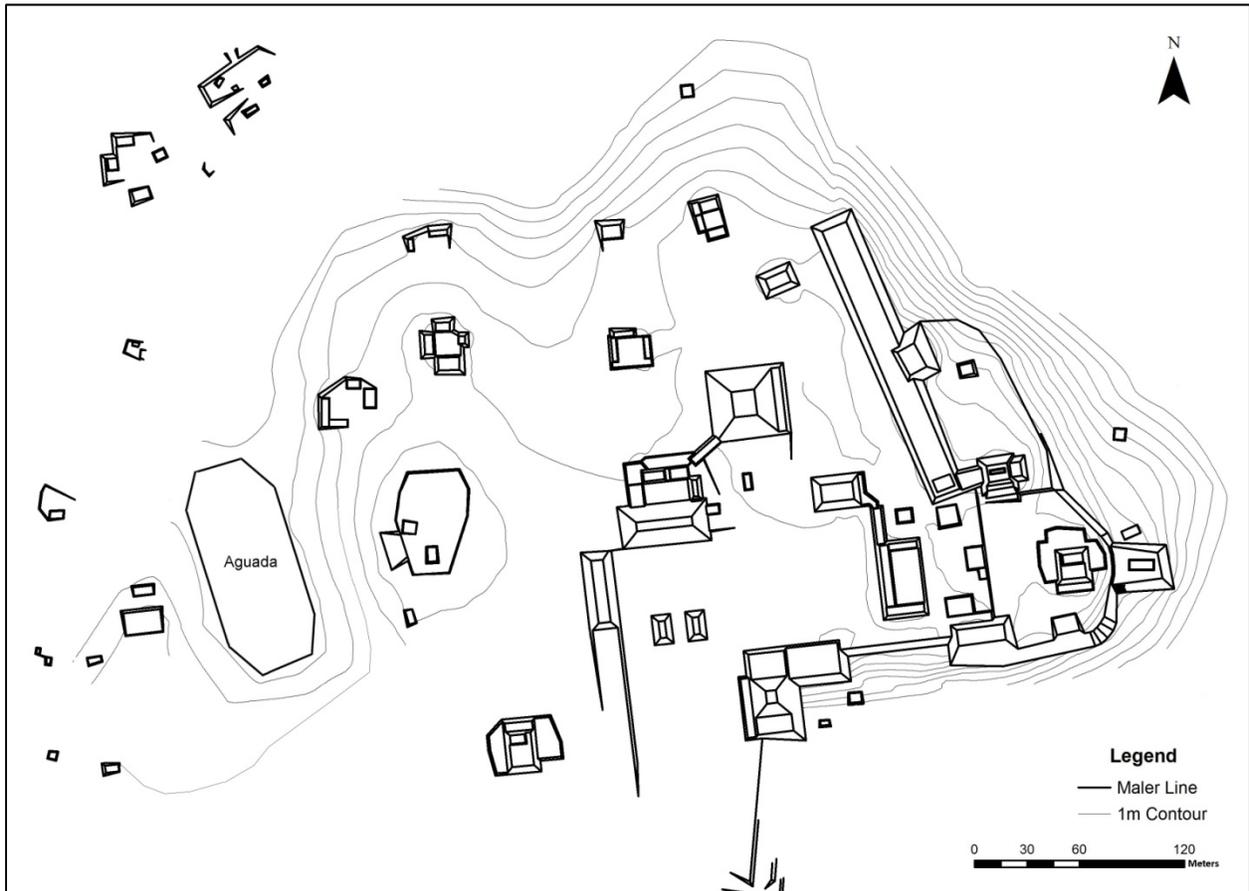
Figure 1. Revised map of Actuncan North.

Much like a topographic relief map, Malarized maps are two-dimensional representations of three-dimensional height. However, only the built landscape is usually depicted using these conventions. Often, Malarized representations of structures will appear as if they are floating in flat space and the topographic setting in which the site is situated is absent. Therefore, both topographic and architectural data are essential in interpreting the ways in which ancient peoples made use of the existing landscape. The primary goal of the 2010 mapping program was to create a detailed topographic relief map that could be used as a base layer for the Malarized drawings of the structures (Figure 1).

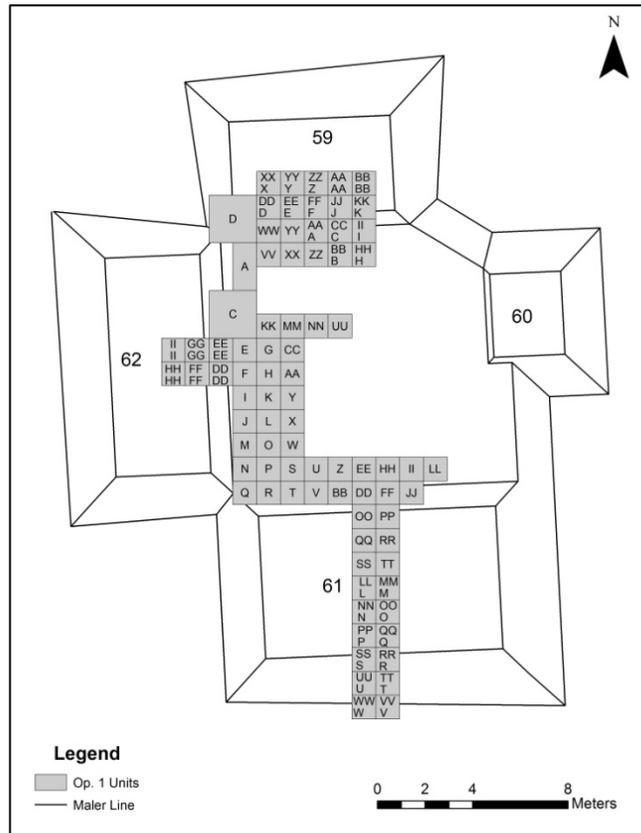
Figure 1. Malerized representation of Group 1 with structures and excavated units labeled.

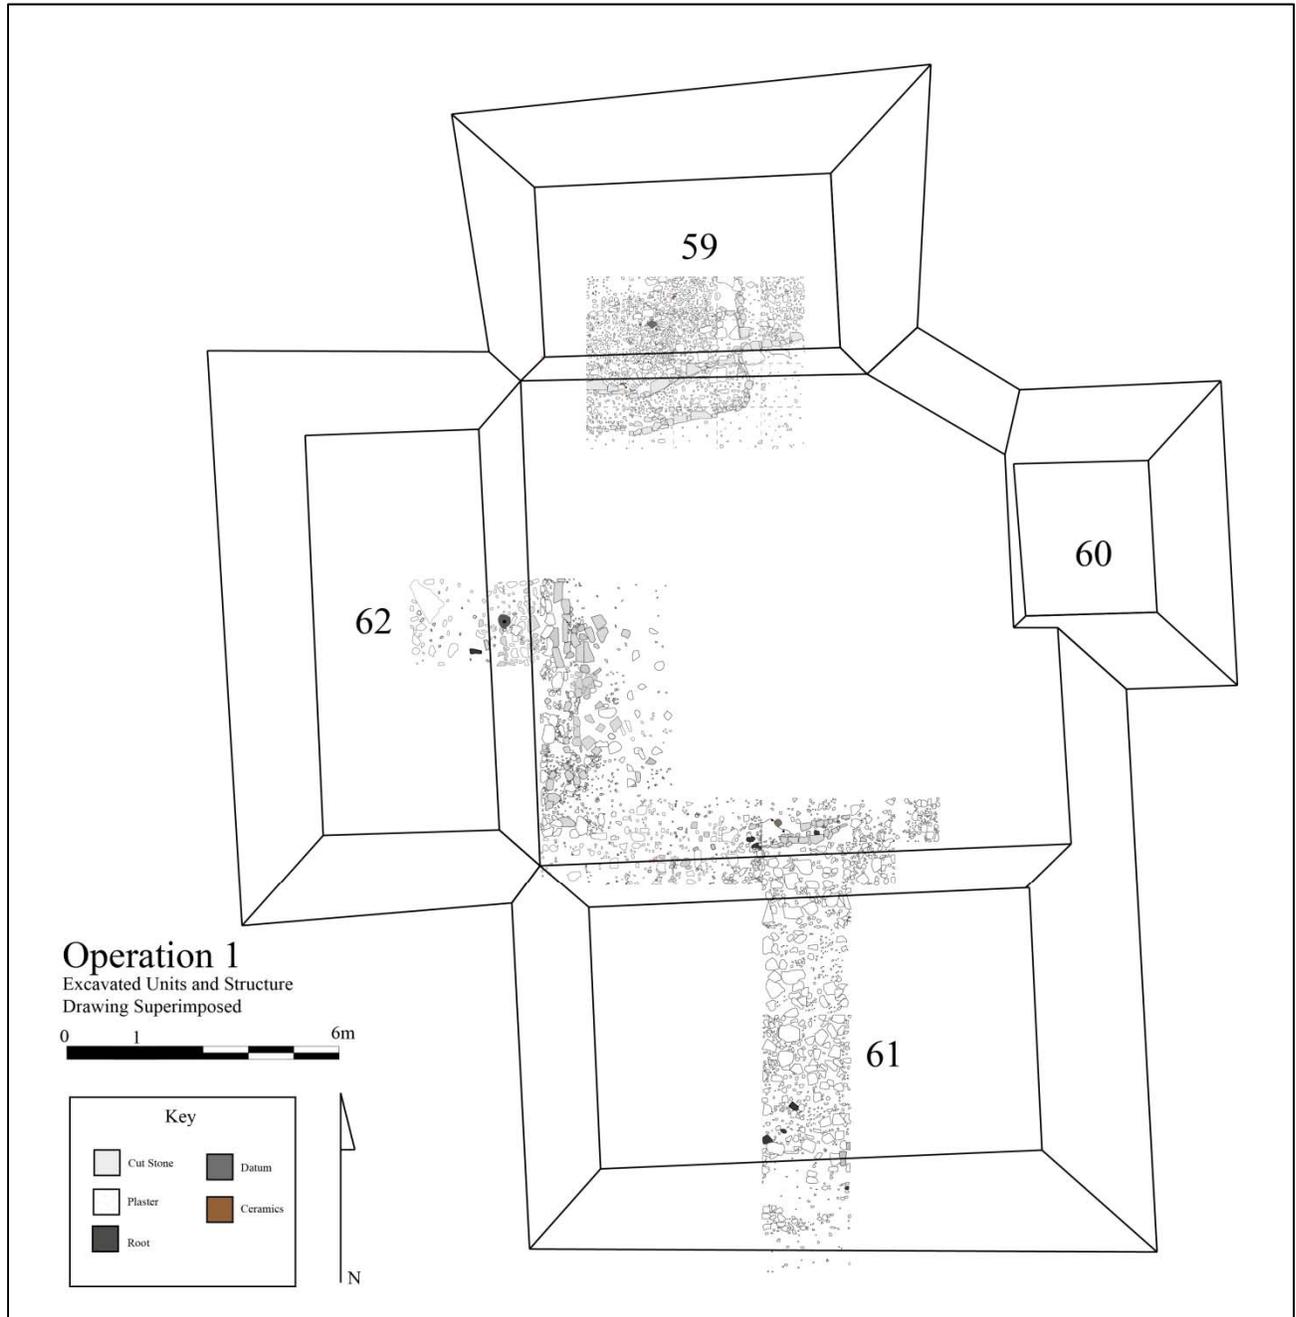
Figure 2. Composite image of terminal architectural features exposed in 2010.

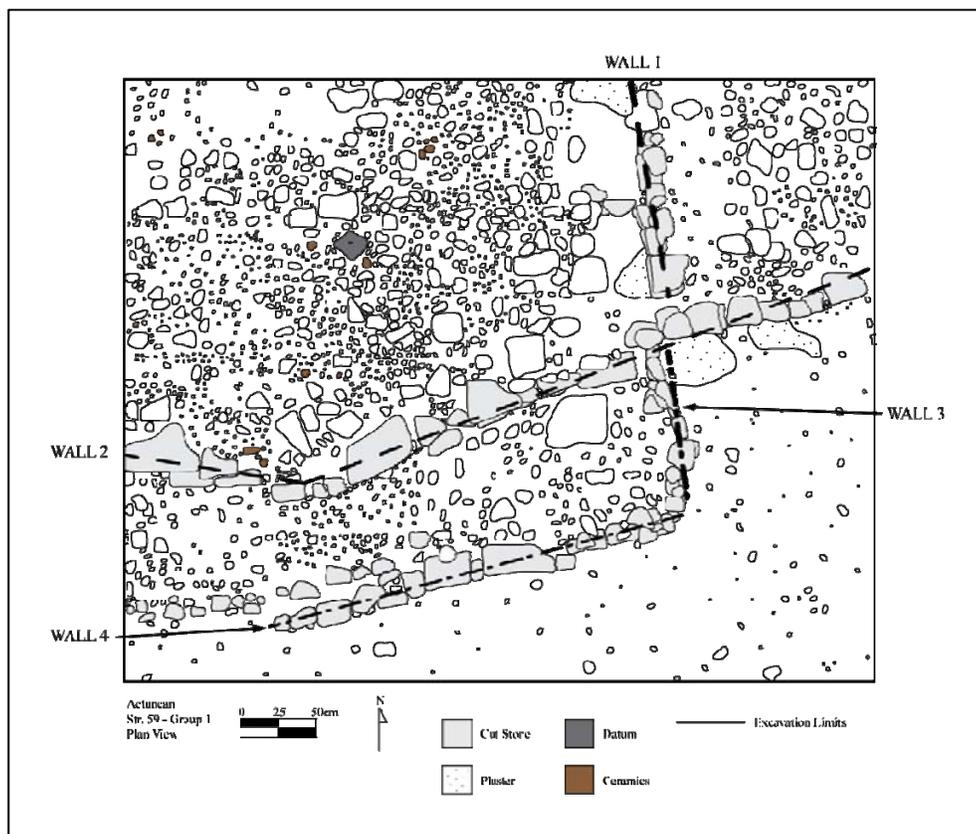
Figure 3. Plan view of Structure 59 with wall numbers displayed.

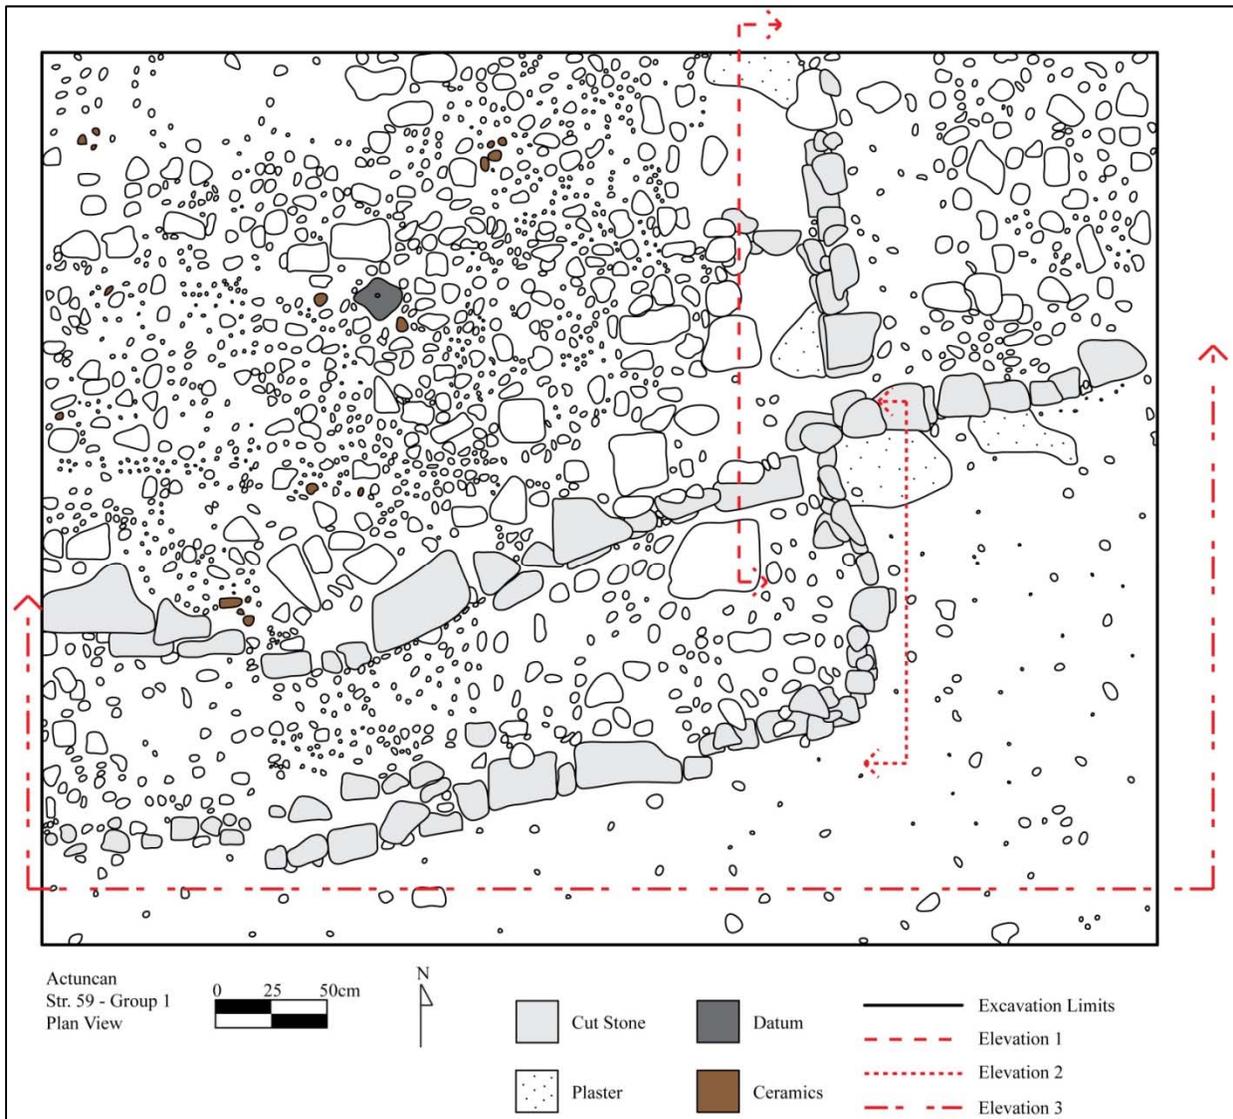
Figure 4. Plan view of Structure 59. Locations of elevation drawings are labeled with dotted lines.

Structure 59 is the northern structure of the *plazuela*. We placed twenty 1 x 1 m units across the southern portion of Structure 59 in attempts to delineate the architectural layout of the structure. A plan view of the excavated units with wall numbers is shown in Figure 3. Elevations are displayed in Figures 5 - 8. The location and direction of elevation drawings are labeled with dotted lines in Figure 4.

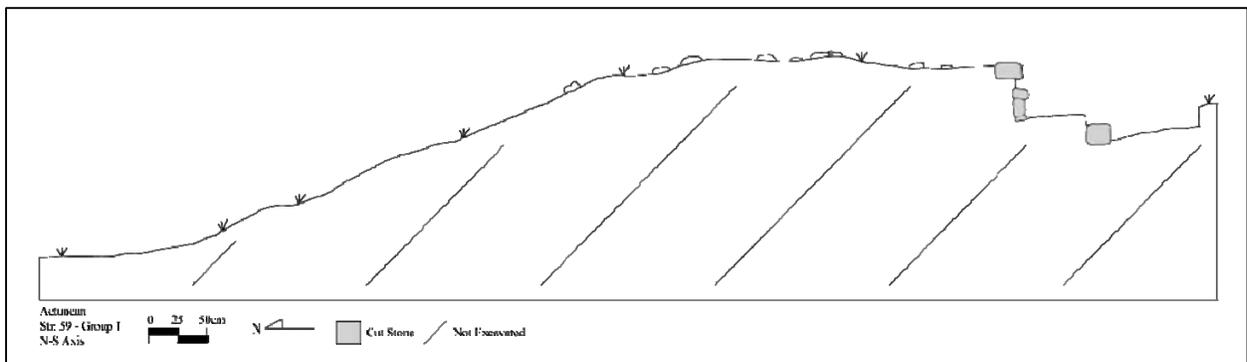
Figure 5. Profile through the middle of Structure 59, facing east including Units ZZZ, FFF, AAA, and ZZ (from north to south).

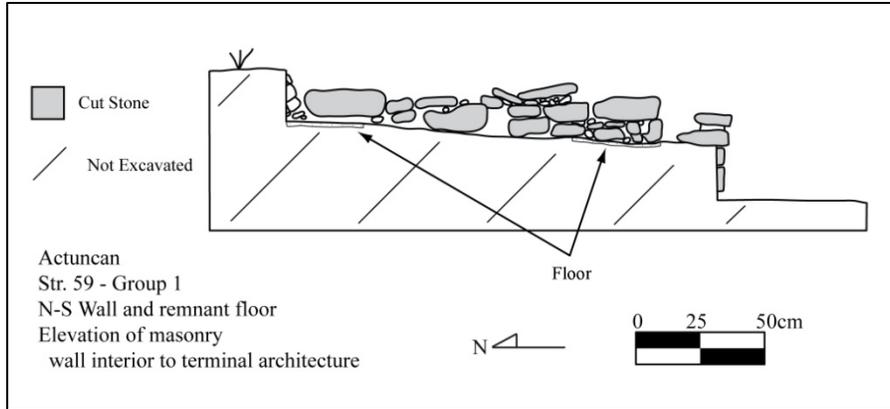
Figure 6. Elevation of the eastern wall of Structure 59, facing east, including Units AAAA, JJJ, and CCC (from north to south). Location is labeled “Elevation 1” in plan view, above.

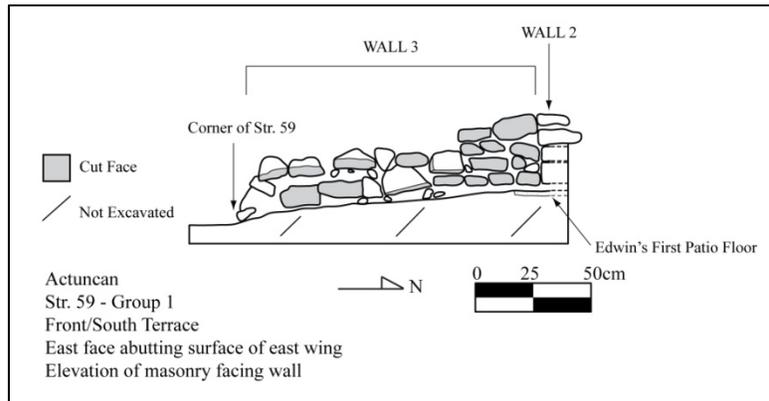
Figure 7. Elevation of the south terrace of Structure 59, facing west, including Units JJJ, CCC, and BBB (from north to south). Location is labeled “Elevation 2” in plan view, above.

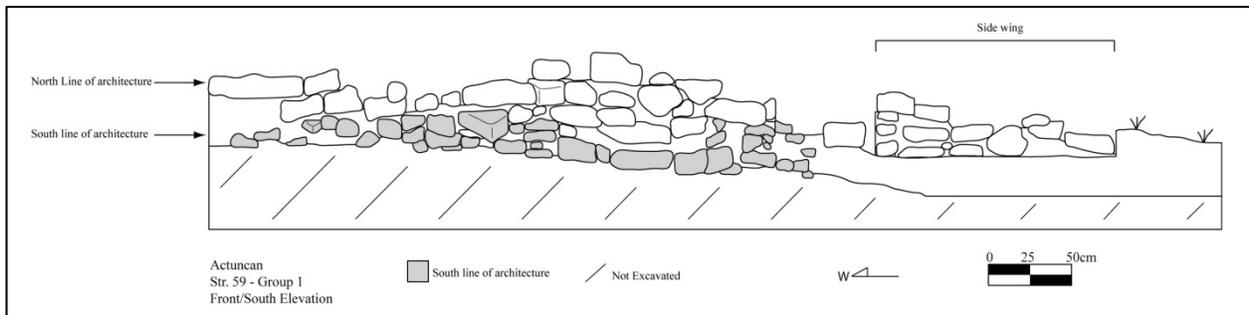
Figure 8. Elevation of the south face of Structure 59 and the eastern wing platform including Units VV, XX, ZZ, BBB, and HHH (from west to east). Note the cut stone façade facing west along the west face of the eastern wing (side wing of Wall 2). Location is labeled “Elevation 3” in plan view, above.

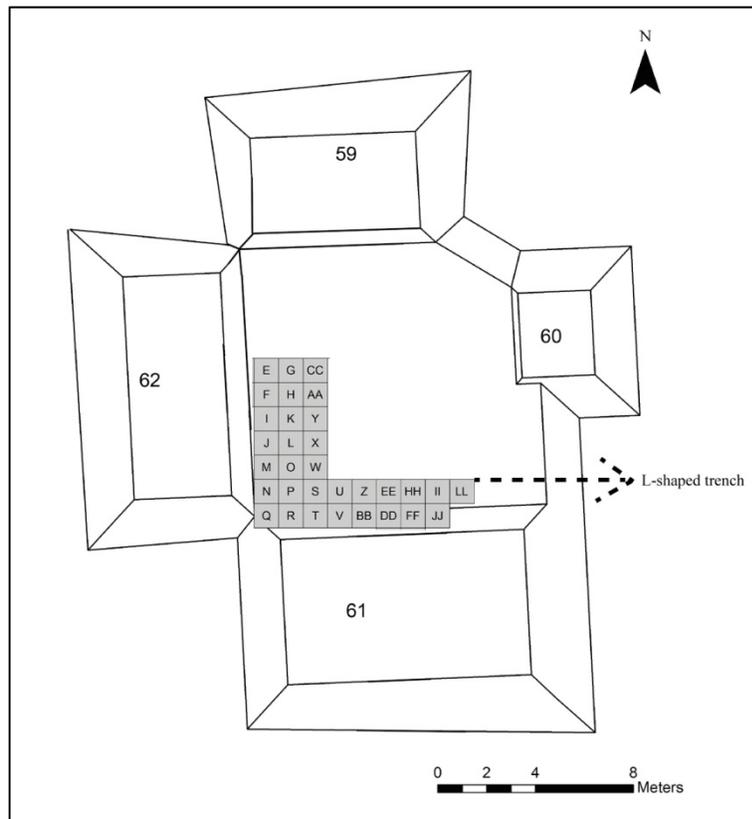
Figure 9. L-shaped trench excavation along western and southern limits of patio.

In order to define the patio-facing sides of Structures 61 and 62 and the last occupied floor of the central patio, we opened a large L-shaped series of 1 x 1 m units at the juncture between the two structures (Figure 9). The clearing excavations began on the southern edge of the 2004 north-south trench (labeled D, C, and A in Figure 1), located west of Structure 59 and north of Structure 62. In the 2004 excavations, multiple stages of construction were noted on the eastern edge of Structure 62. To better define the layout of the terminal architecture observed in 2004, we placed units directly south of the 2004 trench.

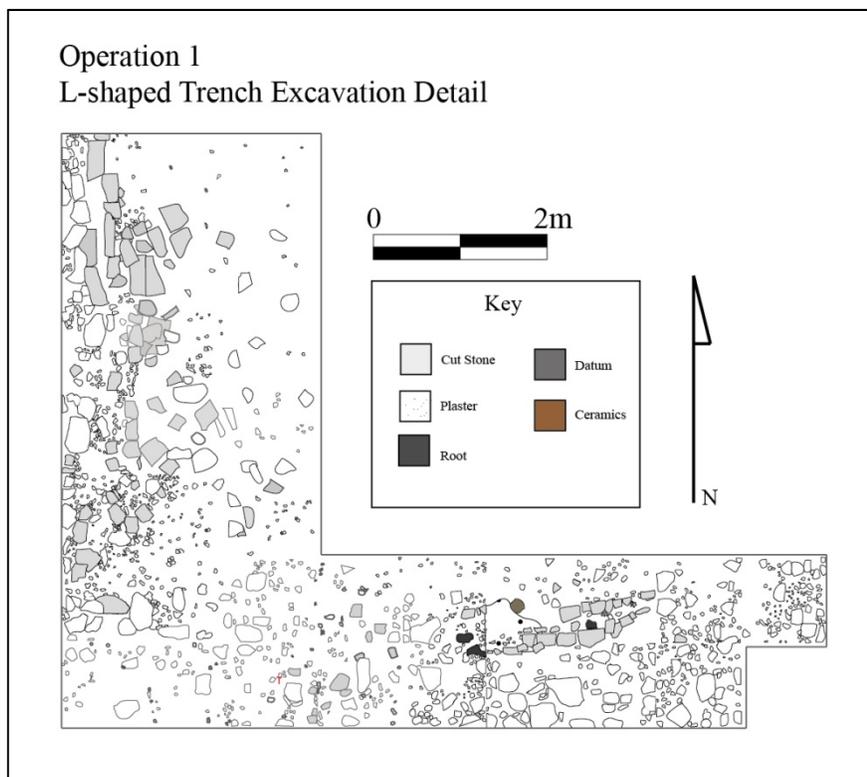
Figure 10. Detailed plan view of terminal architecture uncovered in patio excavations (Units E – JJ, LL).

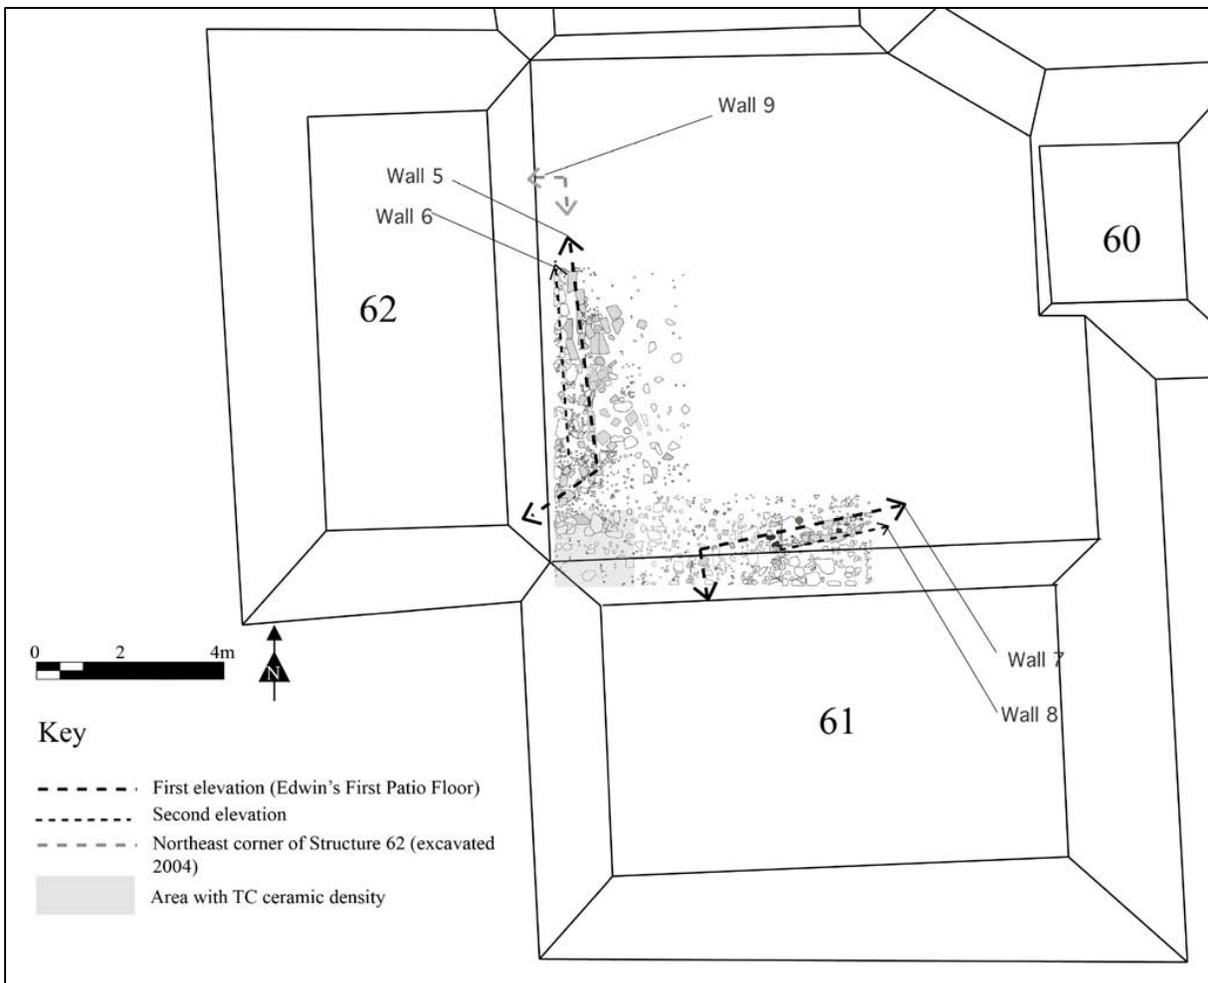
Figure 11. Plan view showing terminal architecture in the southeast corner of patio.

balustrade stone was uncovered near the center of these steps up. There was a lot of out of place stones that collapsed to the west, up to 3 m away. Walls 7 and 8 were uncovered along the northern side of Structure 61. These walls were at a greater depth than Walls 5 and 6 (Figure 11).

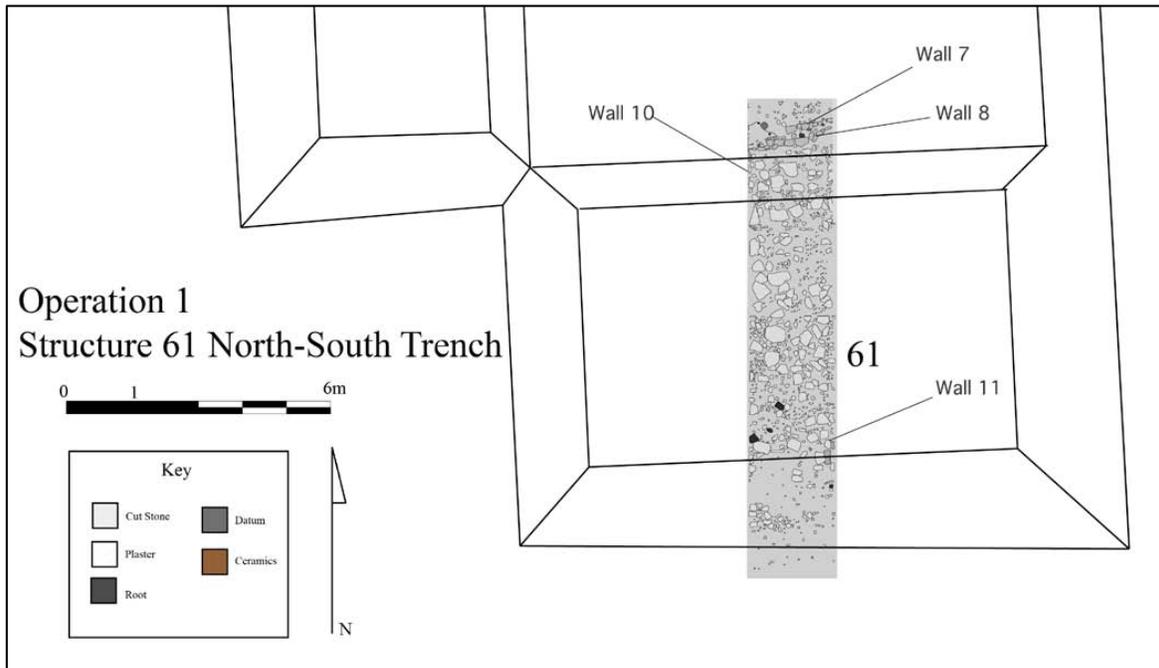
Figure 13. Terminal architecture within trench through central axis of Structure 61.

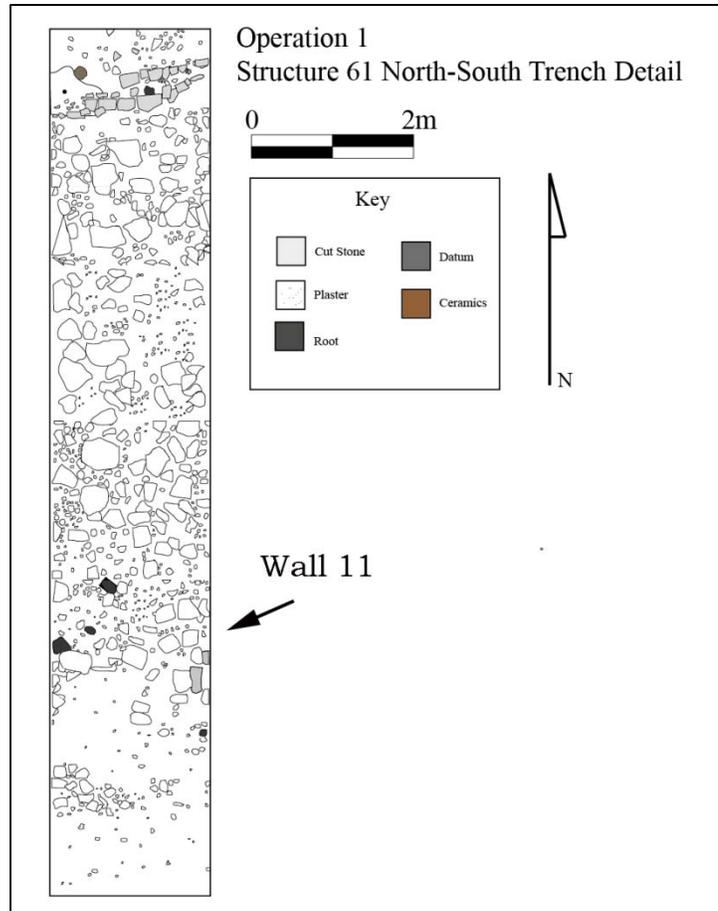
Figure 14. Terminal architecture encountered in trench of Structure 61 from Units EE and HH in the north to Units VVV and WWW in the south.

Wall 11 appears to be a retaining wall located on the southern side of Structure 61. Future excavations behind Wall 11 may reveal whether the cobble fill that is visible on the northern side of the structure is the same as that along the southern edge of the structure. If this is the case, it is possible that Wall 11 was a later edition, built to retain the large cobble fill.

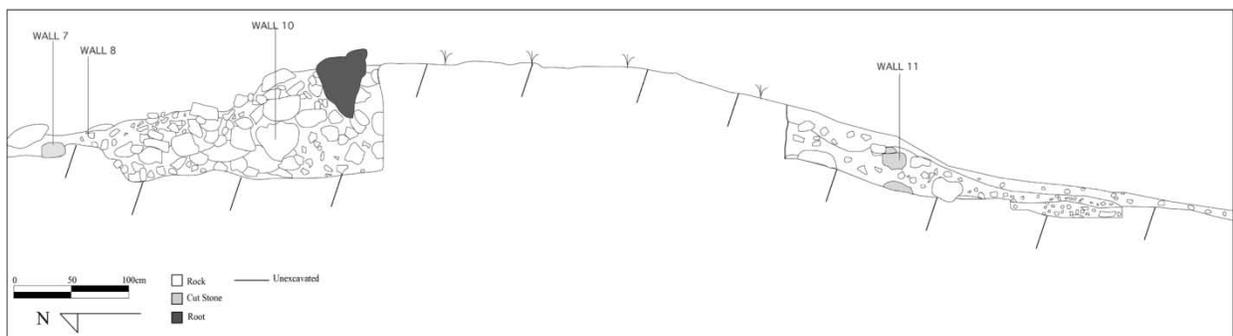
Figure 15. Western Profile of axial north-south trench into Structure 61.

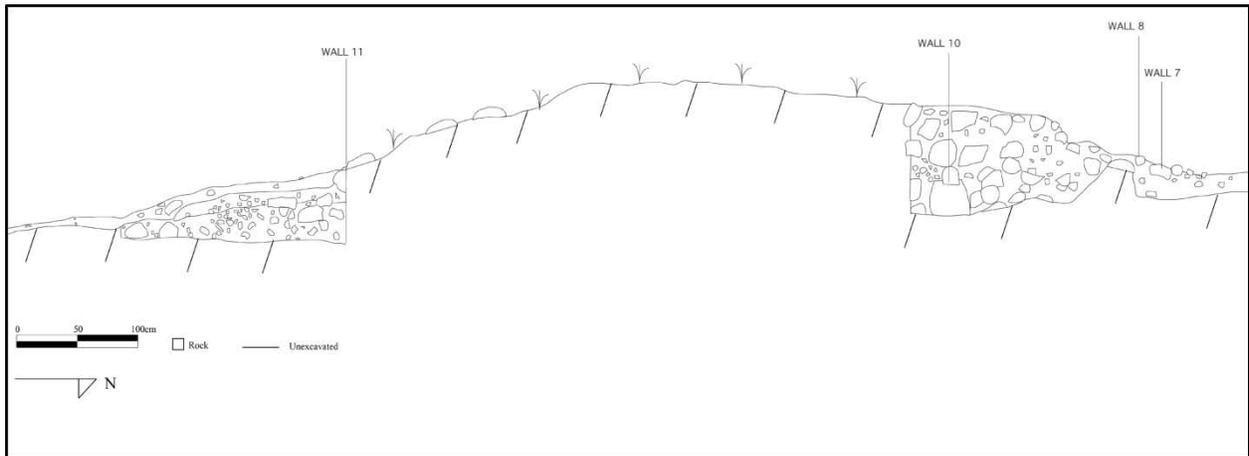
Figure 16. Eastern Profile of the axial trench into Structure 61.

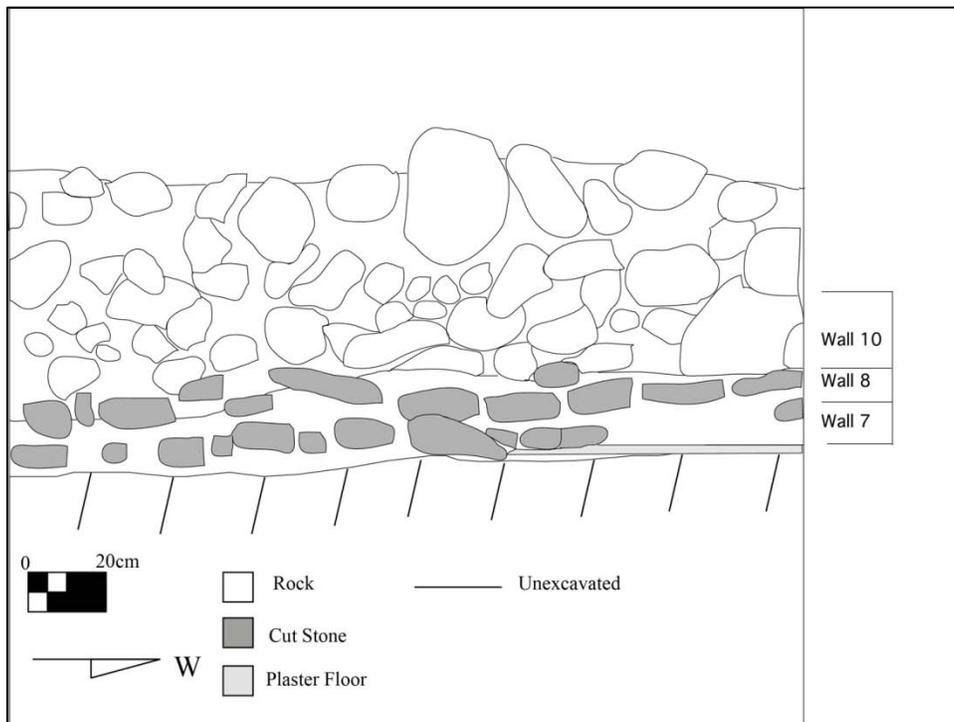
Figure 17. Northern wall (Walls 7, 8, and 10) elevations.

stratigraphic pattern continues on the southern side of Structure 61 as well. Following the same excavation method as the northern side, the southern half of the north-south trench began south of Structure 61 and continued northwards into architecture. In Units SSS and RRR a wall of cut stones were encountered in lot 2 of the units (Figure 17).

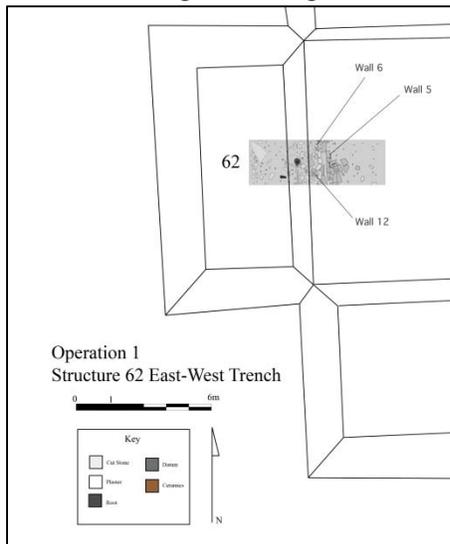
Figure 19. Context of east-west trench through central axis of Structure 62.

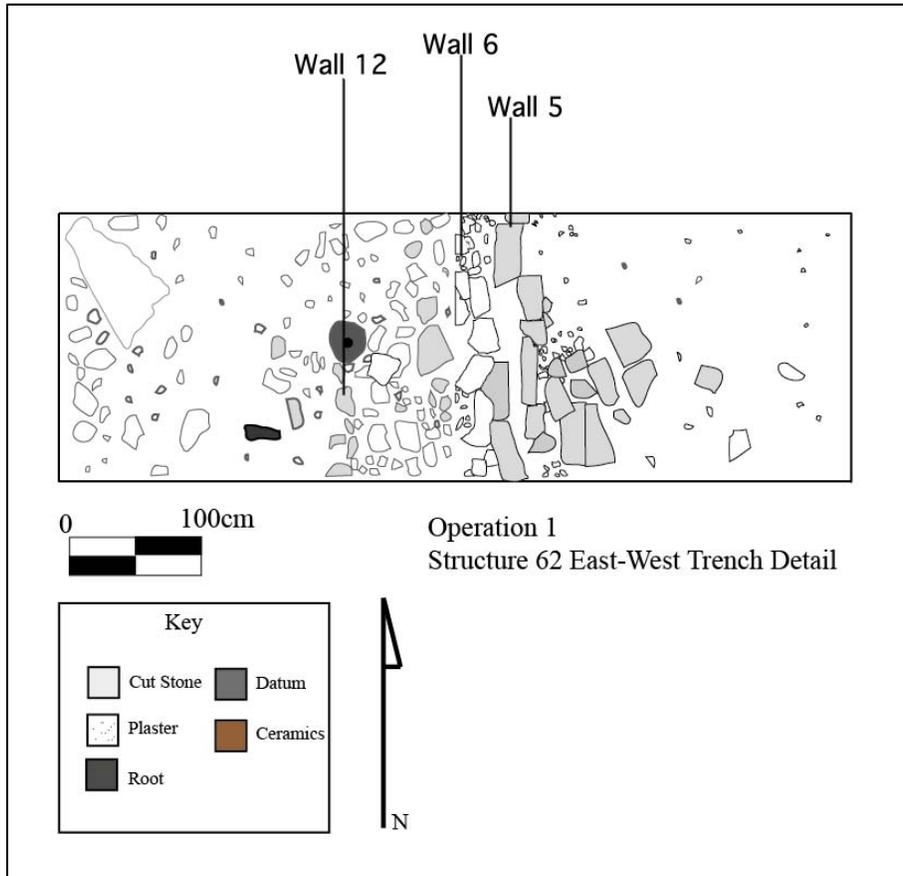
Figure 20. Plan of east-west trench through central axis of Structure 62 (Units E, F, G, H, AA, CC, DDDD, EEEE, FFFF, GGGG, HHHH, IIII).

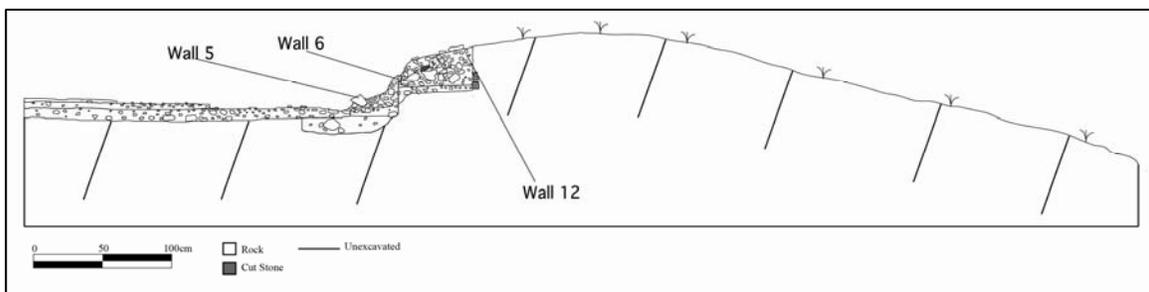
Figure 21. Northern profile of Structure 62.

Late in the season, an east-west trench along the central axis of Structure 62 was opened to help understand the terminal construction phase (Figure 21). No large cobble fill was observed in the substructure of Structure 62, unlike the construction at Structure 61 to the south. Ceramic materials recovered from the axial trench indicate that the terminal structure was used in the Late Classic with limited evidence of Terminal Classic period occupation. Illustrated in Figures 20 and 22 is Wall 12, located directly west of the cobble retaining wall that is associated with the penultimate facade eastern edge of the structure. This wall is aligned along the same axis as a wall that was observed in the 2004 excavation trench profile (called the Str. 62-1<sup>st</sup> terrace wall). The wall in the 2004 trench likely dates to the Late Classic II Hats' Chaak phase. This indicates that in the Late Classic an addition may have been added to the front of Structure 62-1st, similar to the small Late Classic period additions identified along the southern edge of Structure 59. The ceramic materials associated with the east-west trench are mixed. We have identified

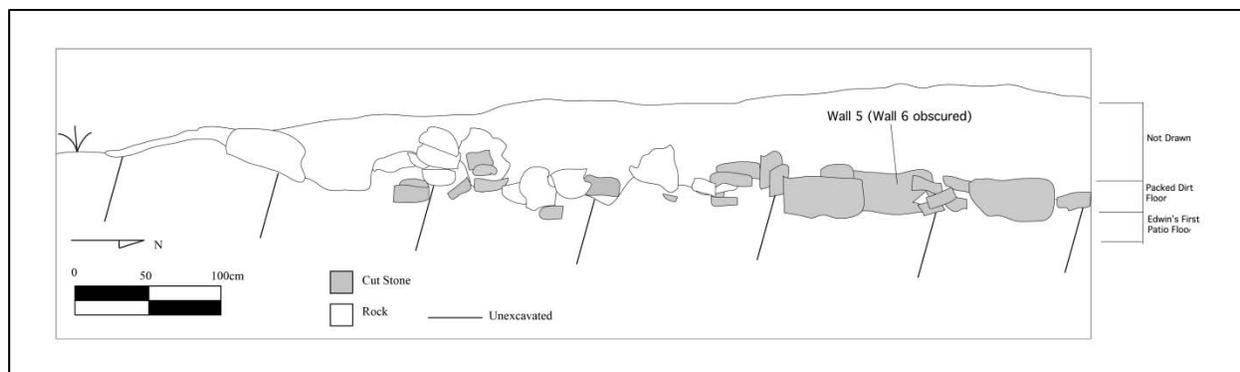
Figure 22. Elevation drawing of Structure 62, facing west.

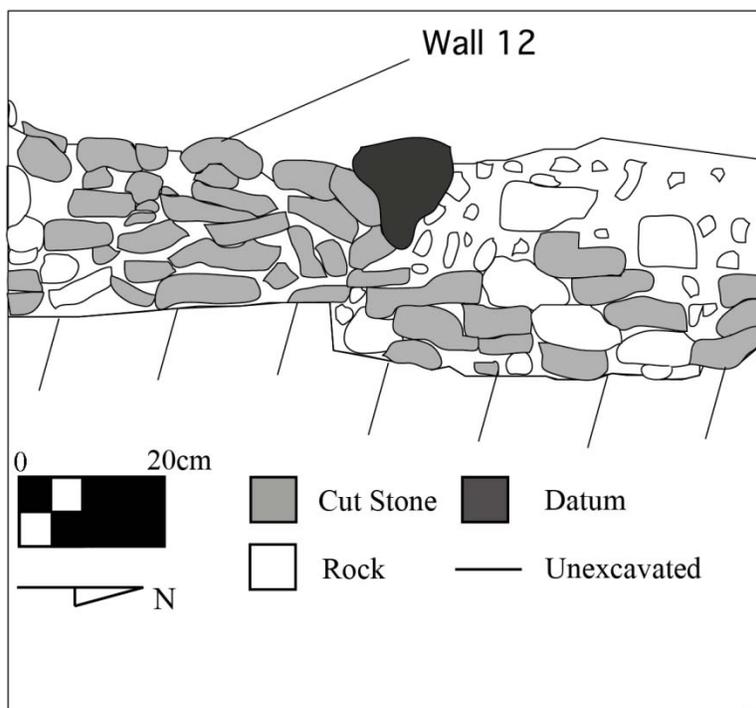
Figure 23. Western profile elevation of Structure 62 (Walls 5 and 6 removed, Wall 12 shown).

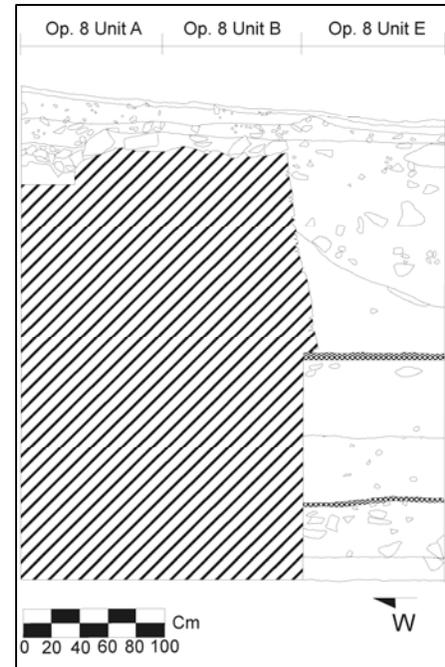
Figure 3. Northern profile of Units A, B and E showing finely prepared terminal surface and earlier floors.

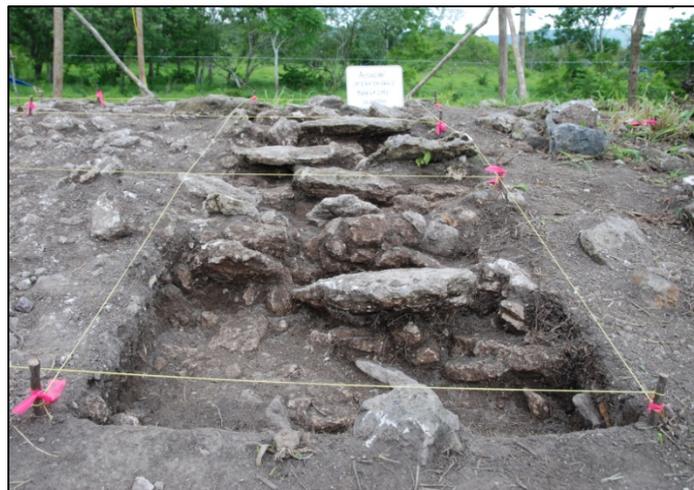
Figure 4. Structure 34 steps (8AA, DD, and GG/2).

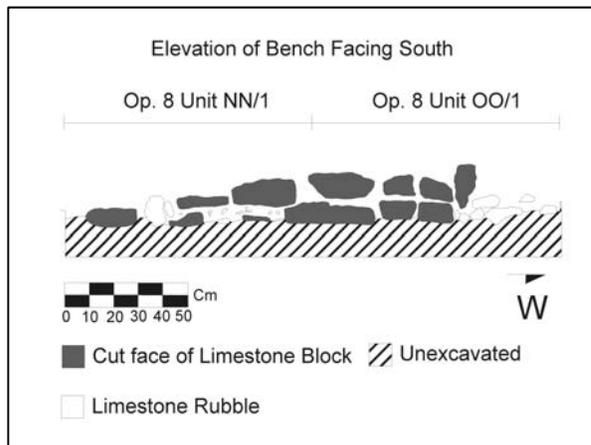
Figure 5. Elevation of Structure 35’s bench facing south (Units OO and NN).

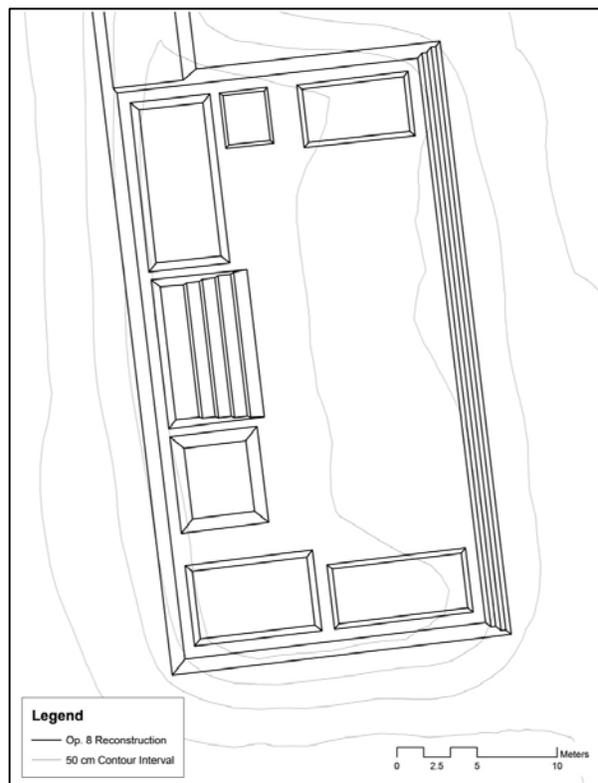
Figure 6. Group 4 reconstruction by Angela H. Keller.

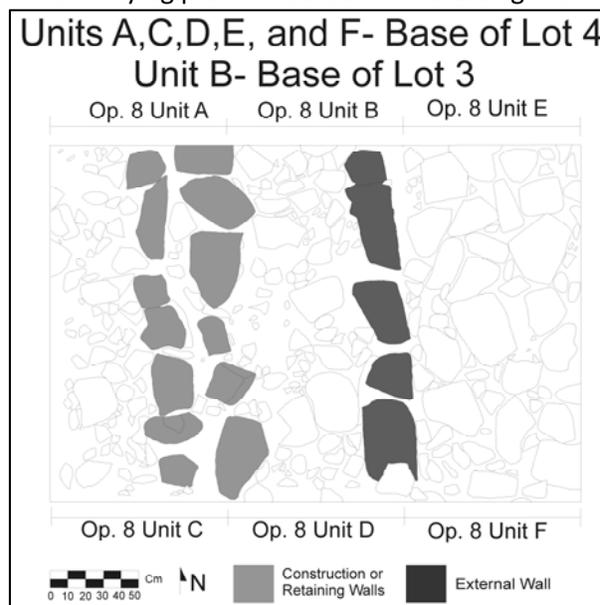
Figure 7. Façade and retaining walls of buried Early Classic building.

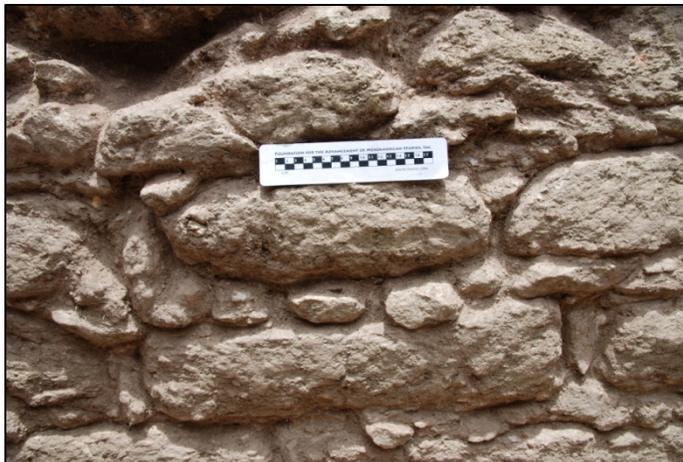
Figure 8. Façade of buried Early Classic building.

We continued to dig outside to the east of the wall in an attempt to better define the architecture. These excavations yielded a very well preserved wall that extends down 9 courses and roughly 1.3m into the fill (Figure 8). Facing stones used for the construction of the wall are large measuring between 40 and 60 cm in width and 15 and 20 cm in height. Wall courses are divided by layers of chinking, consisting of small limestone pieces roughly measuring 5 to 10 cm in size. However, no evidence was found of mortar securing the stones in place. Additionally, small traces of red paint on a few of the wall stones may suggest that the wall was once painted. Many pieces of plaster with red surfaces were found in the fill outside the wall. However, there was no direct association found between these pieces and the wall.

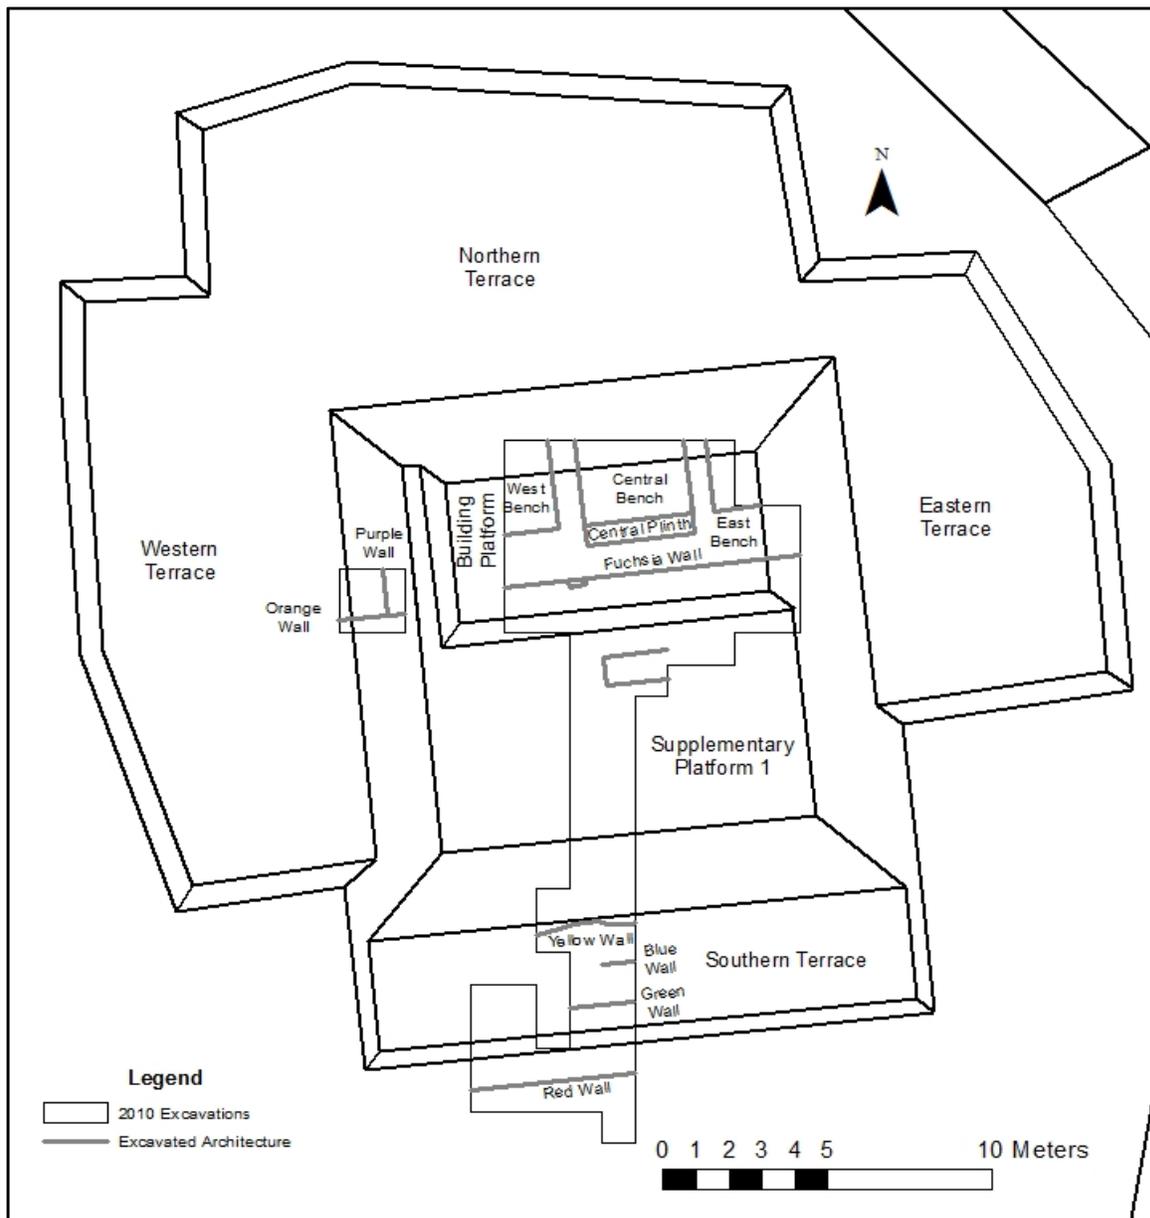
Figure 3. Excavated architectural features.

material from this wall was found overlaying Plaza D. Excavations running north from the Red Wall revealed a double tiered terrace leading to the façade of the structure's main platform (Figure 3). Evidence for the antiquity of Plaza D was provided by excavations in two 1 x 1 m units (6UUU and 6P) south of the retaining wall. Here, excavations revealed an accumulation of collapsed materials from Structure 41 laying on top a sequence of plaza floors. The upper most analytical context, Structure 41 South Plaza Surface, consists of undisturbed modern soil and vegetation. This context represents the modern humus, which rests on top of the collapse of the ancient structure. Below this humus, two different layers of fine sediments were found. These contexts contained a large amount of limestone inclusions, which appear to have been deposited as a result of colluvial erosion or sheet wash that brought down debris from higher up the structure. These two layers of sediments are differentiated by a change in soil color from 10YR 3/1 to 10YR 4/2. Lot 6O/2 contained a small greenstone pendent carved in the image of a god head likely washed down from its place of abandonment further up the structure or from within a fill layer. Importantly, the pendent attaches a certain level of wealth and affluence to the inhabitants of Structure 41. In addition to the ubiquitous small-sized ceramic and lithic artifacts, the sheet wash deposits included small quantities of obsidian and daub. Daub was found in small quantities across these excavations and they likely represent the remnants of *bajareque* construction used to construct the walls of a building on top the central platform. Below these two layers of sheet wash, a talus of chert cobbles and limestone rubble rests just to the south of the remains of Red Wall. This section of limestone rubble represents the collapse of the southern terrace's retaining wall following the structure's abandonment.

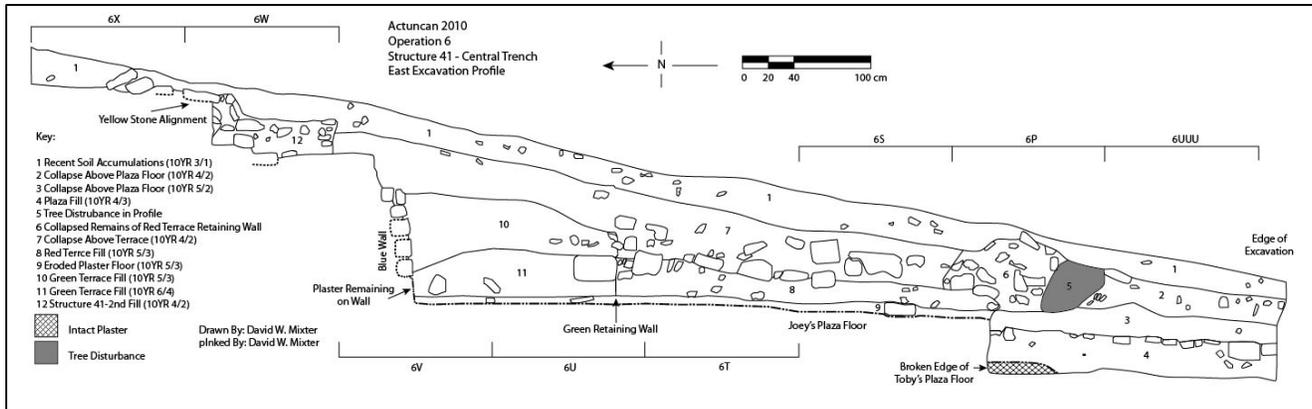
Figure 4. East profile of lower portion of the north-south axial trench.

From test excavations into Plaza D, we began a 2 m wide trench north towards Structure 41 following Joey's (plaza) Floor (Figure 4). Excavating through Red Wall (a retaining wall) into the Red Terrace, we discovered that Red Wall was roughly constructed out of limestone boulders and large chert cobbles. If this wall was ever faced by cut blocks they must have been entirely robbed in antiquity.

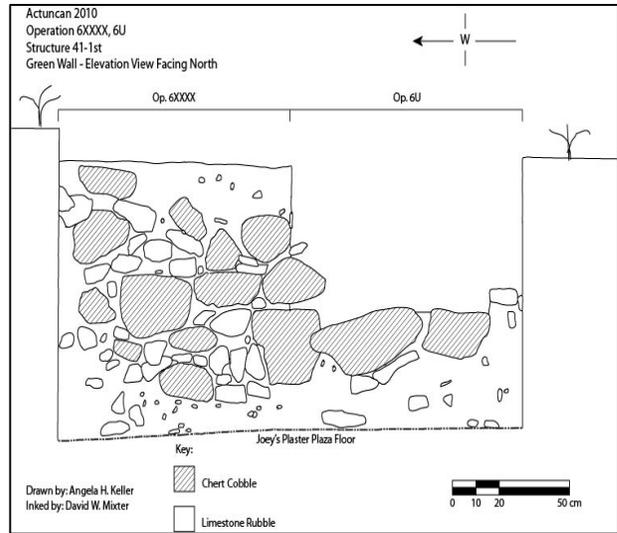
Figure 5: Green Wall elevation facing north.

The upper retaining wall, Green Wall, forms the front of Structure 41's second (and higher) southern terrace (Green Terrace). It was found in much better shape than Red Wall. This wall consists of neatly stacked large limestone and chert boulders, their most naturally flattened faces facing south. Despite the lack of cut stones, Green Wall appears to have been well constructed and is quite stable. Within our 2 m wide trench, the wall was found well preserved to a height of 80 cm in the western portion of the trench. In the disturbed eastern section, only the basal course of stones remained. Based on the mass of collapsed stones found laying on top of Red Terrace and findings detailed below from Units W, Y, and Z further north in the trench, this retaining wall may have risen another 10 to 20 cm above its current height, likely forming a terraced activity area (Green Terrace), which was much higher than Red Terrace below it.

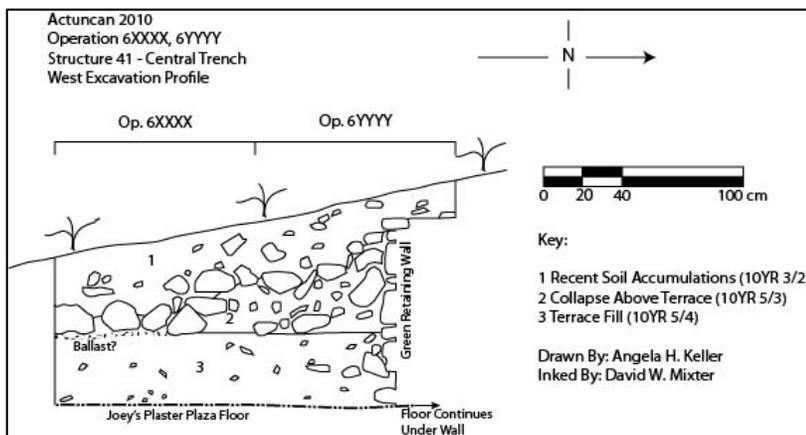
Figure 6. West profile of axial trench.
