# Actuncan

# **Actuncan Archaeological Project: Report of the 2010 Field Season**

Report submitted to the Belize Institute of Archaeology

March 2011

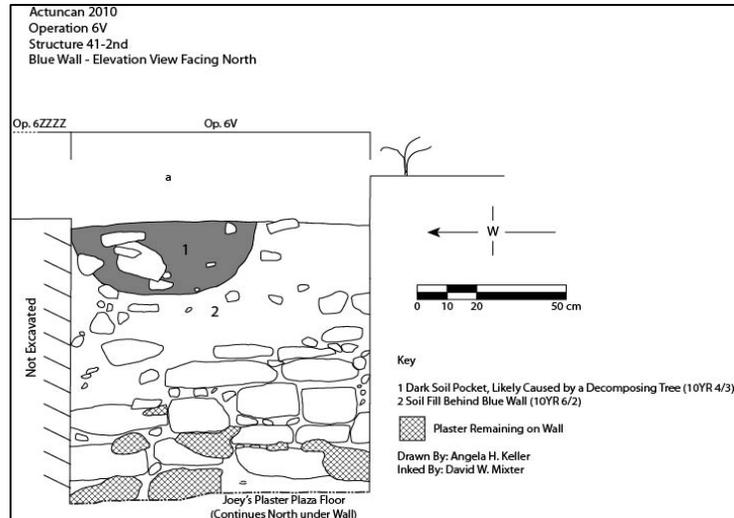
Figure 7. Blue Wall elevation.

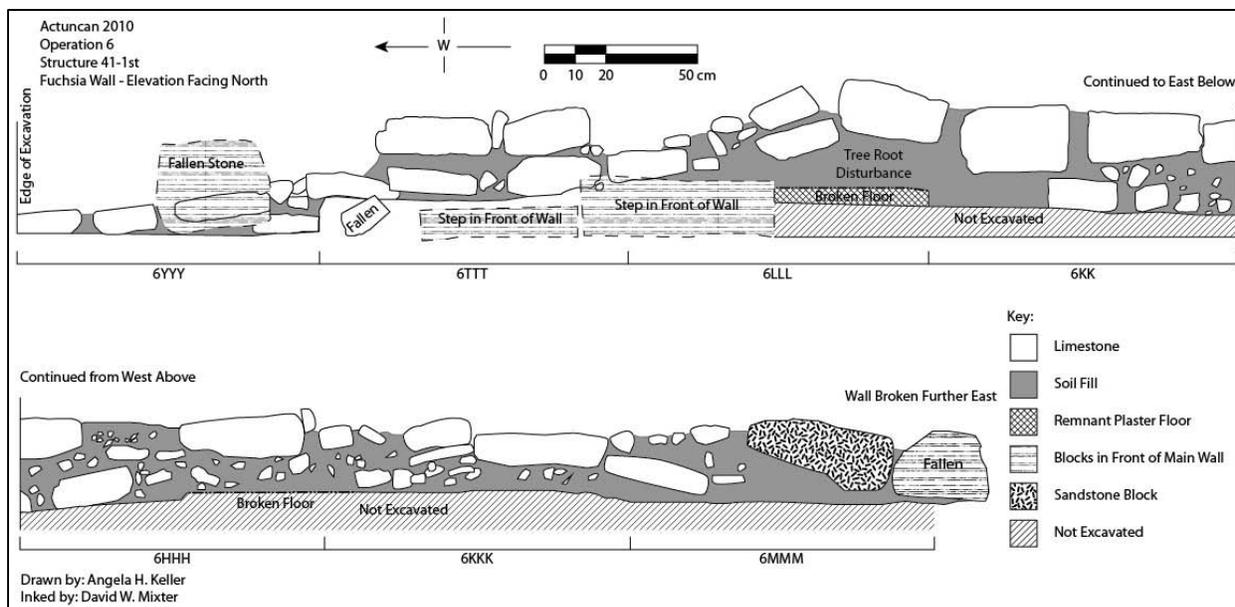
Figure 11. Fuchsia Wall elevation.

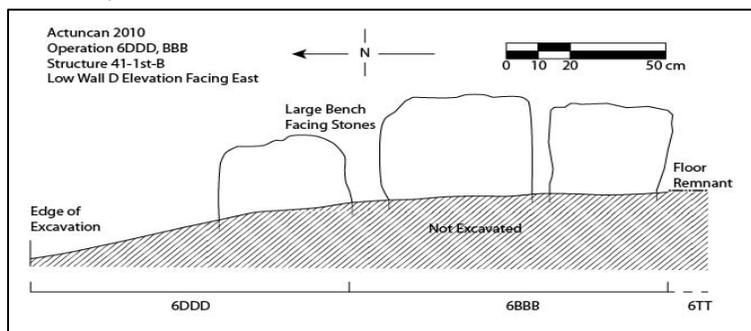
Figure 13. Low Wall D elevation (after field drawing by Angela H. Keller).

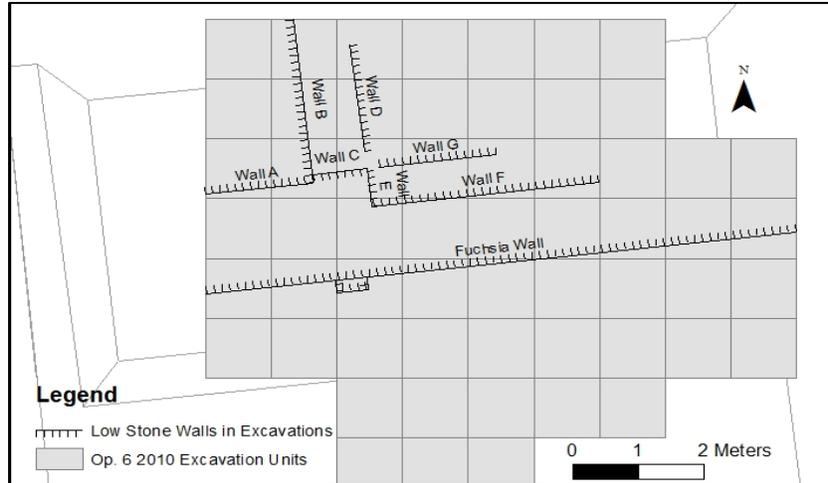
Figure 12. Schematic of low walls on summit of Structure 41.

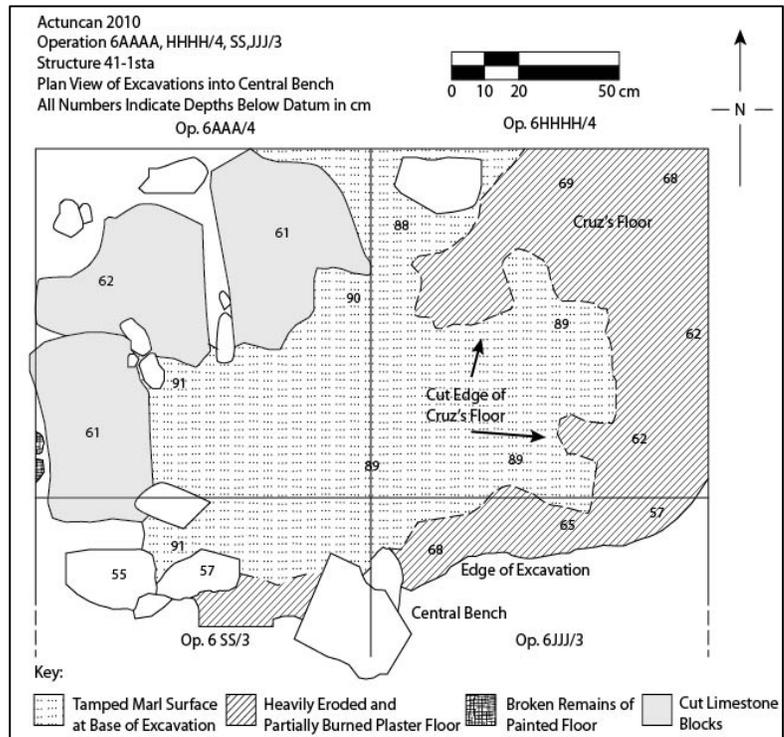
Figure 14. Plan view of excavation into central bench (after field drawing by Marlon Cocom).

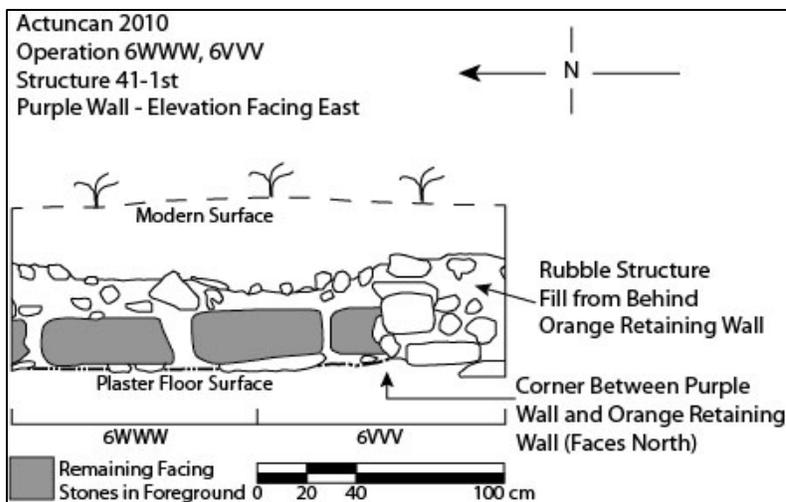
Figure 15. Purple Wall elevation (after field drawing by Don C. Perez).
